# A Preliminary Study of Rainfall-Induced Mass-Wasting Events in the Deccan Trap Terranes of Satara District, Maharashtra, India

<sup>1</sup>Senior Geologist, <sup>2</sup>Assistant Geologist, <sup>3</sup>Junior Geologist,  
Groundwater Surveys and Development Agency, Satara, Maharashtra, India

This paper presents a comparative geological, geomorphological, and engineering analysis of three recent rainfall-induced slope failures within the Western Ghats escarpment (Morpho-Zone Aa) of Satara District, Maharashtra, India. The studied locations include the villages of Kurulbaji (Satara Taluka), Mhate Mura (Jawali Taluka), and Sayghar (Jawali Taluka). Utilizing real-time field mapping data, structural configurations, spatial metrics, and hydro-geological observations compiled between 2025 and 2026, we characterize the failure kinematics ranging from shallow fluidic debris flows to deep-seated historical creep and anthropogenic slope instabilities. The underlying lithology across all domains consists uniform Deccan Trap basaltic lava flows capped by un-engineered, highly porous overburden of variable thickness. Our findings indicate that extreme, short-duration monsoonal precipitation

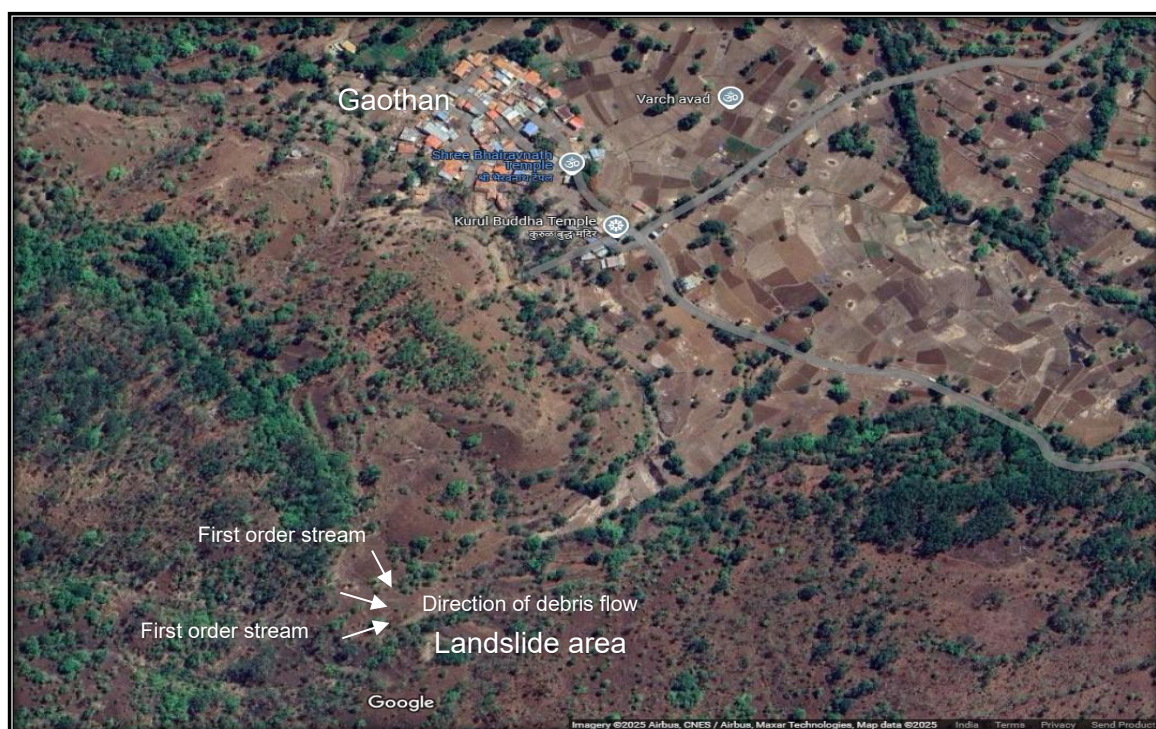
**Photograph No. 1- Google earth Image of Affected Study area of Kurulbaji village**

zones using GPS-enabled NoteCam frameworks, google earth images are also used. (Photograph No.1) Subsurface structural data was inferred from daylighting groundwater points, open tension fractures, and exposed soil-rock profiles along infrastructure cuts. All three study sites sit within Morpho-zone Aa of the Western Ghats, characterized by highly undulating, rugged basaltic hills.

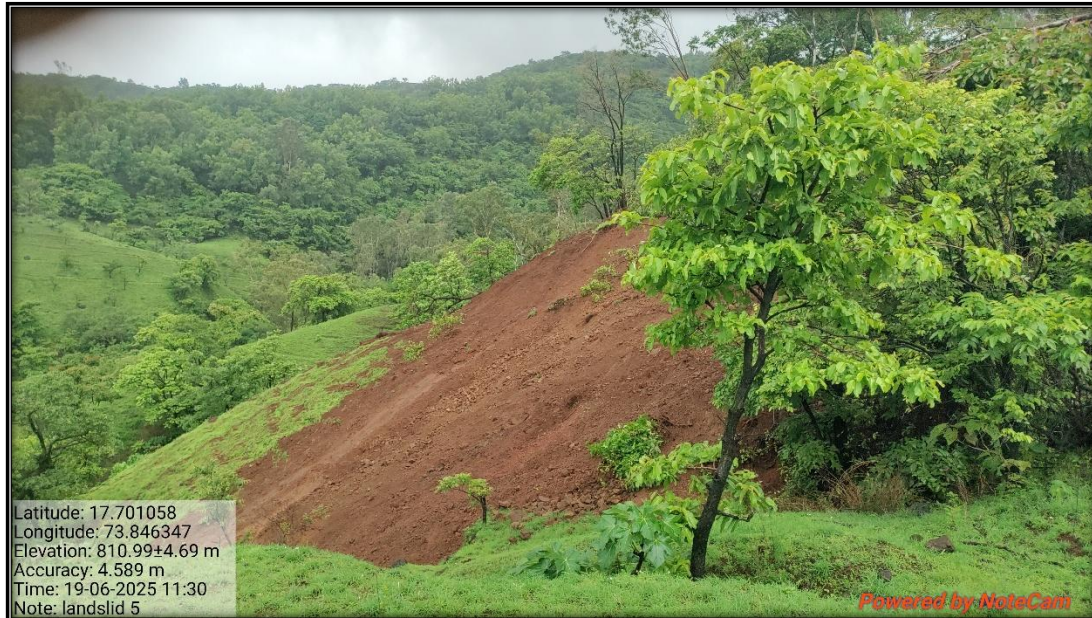
**Photograph No.2 View of Landslide in Kulkajai Village**

The joint field survey executed on June 19, 2025, responded to an active slope failure tracking South of the primary residential

settlement (Gaothan) at an aerial distance of approximately 500 m. The mass failure initiated on a steep hill profile trending Northeast-Southwest (NE-SW). (Photograph No.2)

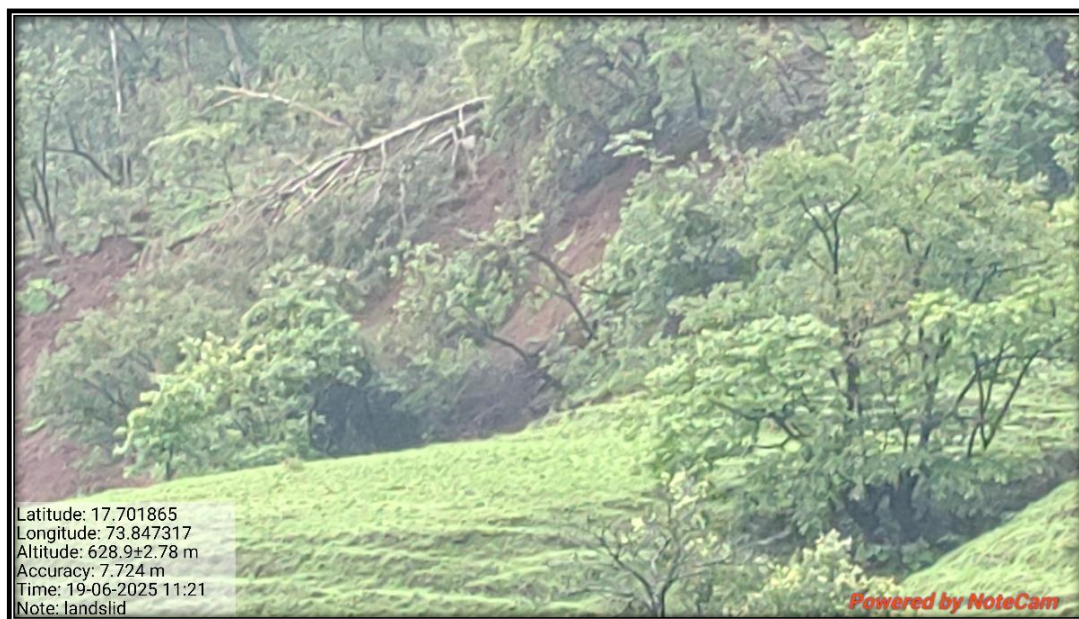
**Photograph No.3 effect of Landslide in Kulkajai Village**

West. Field tracking fixed the primary debris flow failure plane at coordinates 17°42'03.1"N, 73°50'47.2"E. Kinematic observations confirmed a distinct southward trajectory. The material involved was

classified as an un-sorted, fluidic debris matrix containing coarser weathered rock fragments mixed within a highly saturated silty-clay soil profile. (Photograph No.3)

Dynamic monitoring during the monsoonal surge revealed a slow-velocity, active debris flow. The shear force was sufficient to cause widespread root tilting and downslope tumbling of mature Eucalyptus trees embedded in the moving mass. The lateral flanks of the slide mass are bounded by

first-order torrent channels (rills) that transition down-gradient into a combined second-order stream (Nala) traversing the low-lying valley basin. Notably, no immediate subsurface landmass subduction or deep-seated rotational shearing features were observed along the main scar.

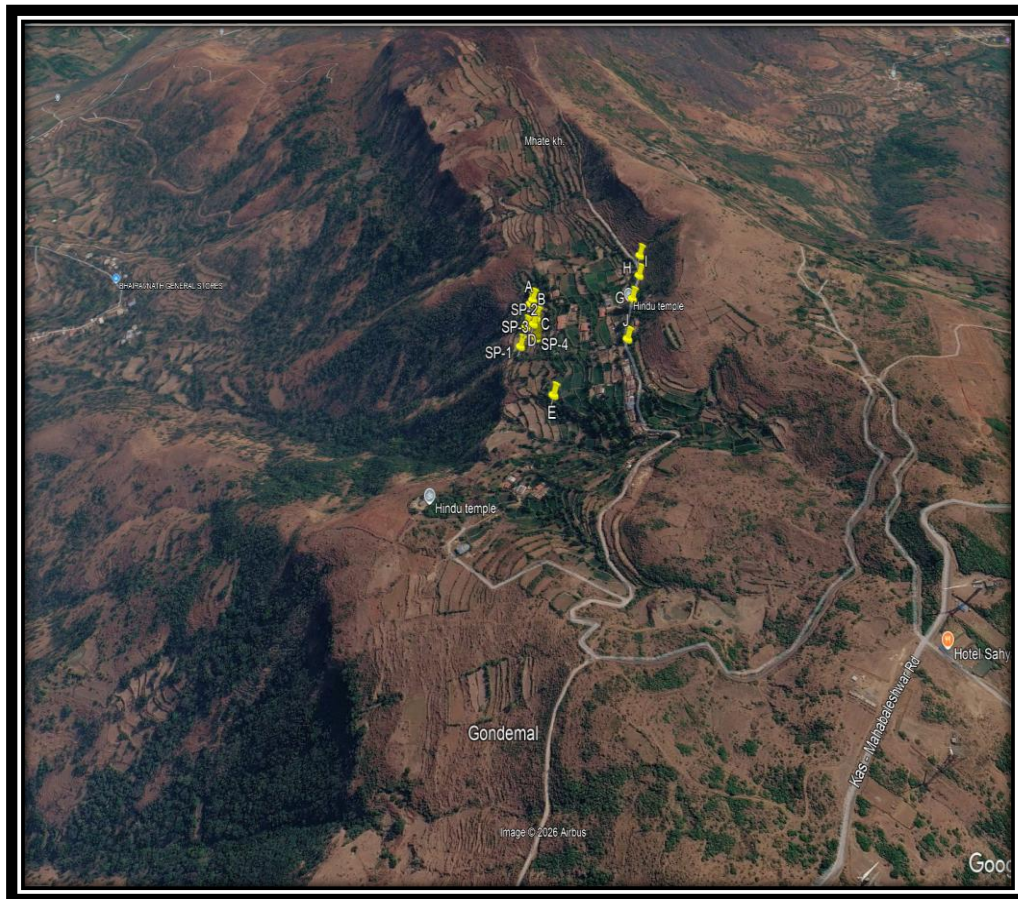
Photograph No.4 Google earth Image of Affected Study area of Mhate Kh.

The mapping operation conducted on July 10, 2026, revealed a complex, high-risk slope failure configuration distributed both upslope (South) and downslope (North) of the primary Gaothan. The village settlement is geomorphologically situated on a volatile slope transition phase, moving from upper

concave accumulation profiles containing thick, cohesive colluvial soil into steep convex break-of-slopes that are highly prone to gravitational shearing seen in Google earth Image (Photograph No.4). Due to the severe structural threat, 42 resident families had been evacuated to temporary state shelters prior to the survey.

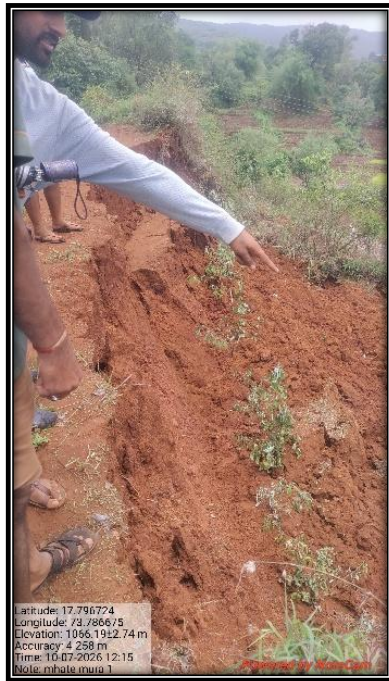
**Photograph No.5** Picture showing Downslope Mass Creep

**Downslope Mass Creep and Tension Fracturing (North of Gaothan):** An active soil avalanche zone (Photograph No.5) trending East-West propagates approximately 200 m downslope from the

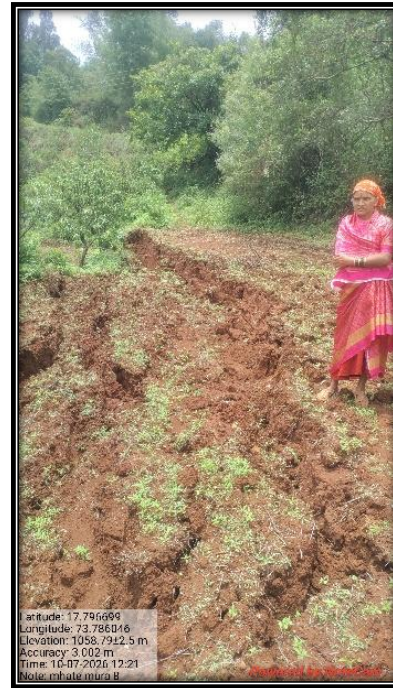
**Photograph No.6** Picture showing Tension Fracturing

village edge. Prominent open tension cracks and mudcracks (Photograph No.6) were logged at coordinates  $17.796629^{\circ}$  N,  $73.785876^{\circ}$  E, indicating slow, ongoing gravitational slope creep.

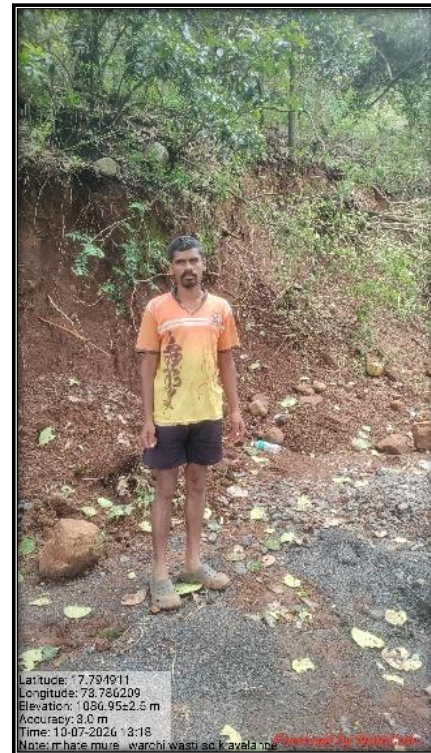
**Photograph No.10** Picture showing Linear Road cutting

**Upslope Structural Cut-Slope Failures (South of Gaothan):** Linear Road cutting (Photograph No.10) directly south of the village has drastically modified the slope

profile. Unstabilized cut-slopes have triggered active soil avalanches stretching linearly from coordinates ( $17.794911^{\circ}$  N,  $73.786209^{\circ}$  E) to ( $17.795034^{\circ}$  N,

**Unsupported Infrastructure Cuts:** Linear road excavation along steep slopes (e.g., Mhate Mura South) creates vertical, unsupported cut-faces. This layout removes lateral confining pressure from the thick soil mantle, exposing the un-sorted basaltic boulder matrix to immediate gravitational failure.

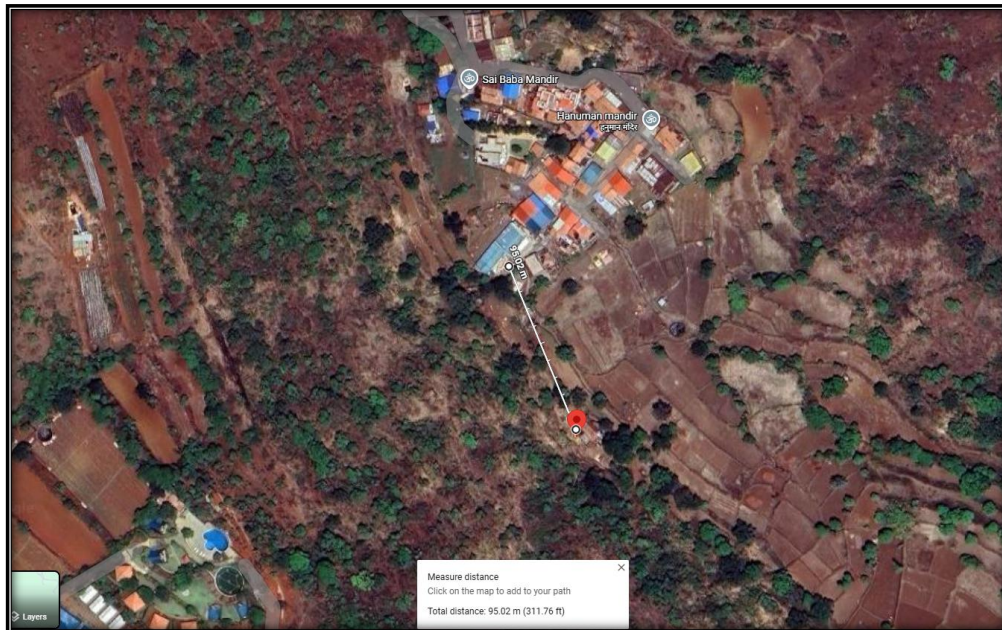
**Photograph No.11 Google earth Image of Affected Study area of Mhate Kh.SayagharVillage Taluka Jaoli**

The technical investigation executed on July 8, 2026, mapped a rainfall-induced, shallow, rapid debris flow tracking approximately 95 m northeast (aerial distance) from the main

village settlement (Photograph No.11). The spatial configuration of the mass movement was bounded by an Initiation Zone (Crown) at 17.850090° N, 73.805987° E and a Deposition Zone (Toe) at 17.850124° N, 73.806275° E.

The kinematics followed a strict West-to-East trajectory, terminating abruptly at the base of the hill lock. The displaced material was composed of poorly sorted, coarse angular rock fragments,

basaltic saprolite, and topsoil bound together by highly saturated clay (Photograph No.11). The flow mass incorporated sheared, shallow-rooted structural vegetation, dominated by native bamboo clusters.

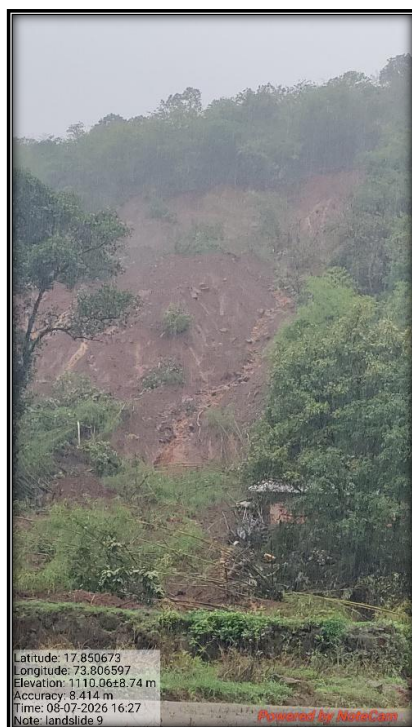
**Photograph No.12 Picture showing Debris flow**

While the primary debris lobe was temporarily static during field tracking, active rill scours and transient streamlets (<30 cm depth) were actively forming across the failure scar. In addition to the

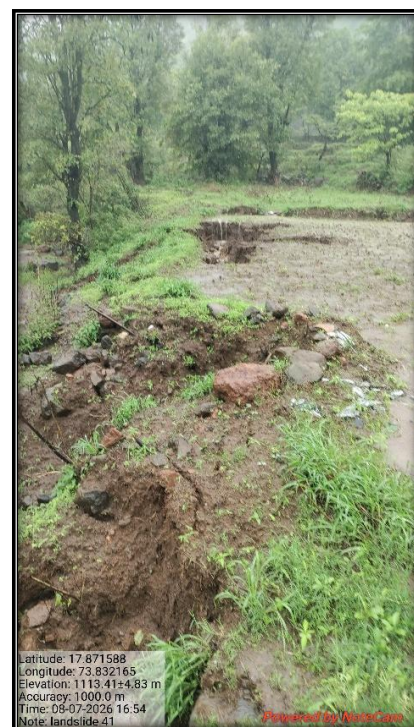
**Photograph No.13 Picture showing Soil erosion**

main slope failure, a secondary zone of minor surficial soil erosion ((Photograph No.13). driven by concentrated overland sheet flow was mapped 41 m east of the Gaothan. Interviews with village elders
