# Evacuation Per Arthroscopy of Wire Migration Following of Broken Patella Cerclage Wire: A Case Report

**Case Presentation:** We present the case of a 56-year-old male with a history of a right patellar fracture, which was managed with open reduction and internal fixation utilising cerclage wiring two years ago. The patient had growing anterior knee pain for one

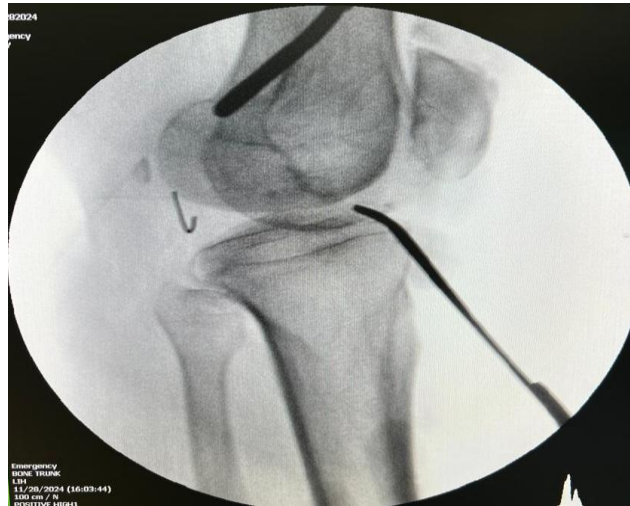
conducted during surgical planning revealed the migration of a K-wire into the intra-articular space of the knee joint, an anomaly not previously identified through clinical or conventional radiography assessment.

**Figure 2. Intra-operative C-arm exploration and cerclage wire showing sign of migration in lateral view**

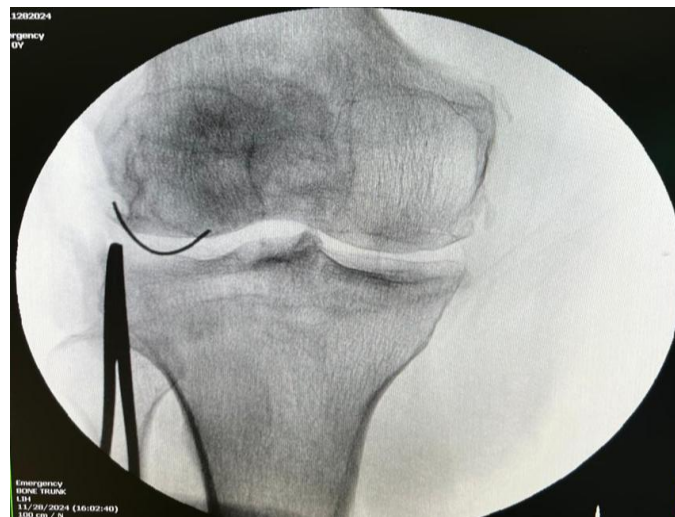
**Figure 3. Intra-operative C-arm exploration and cerclage wire showing sign of migration in AP view**

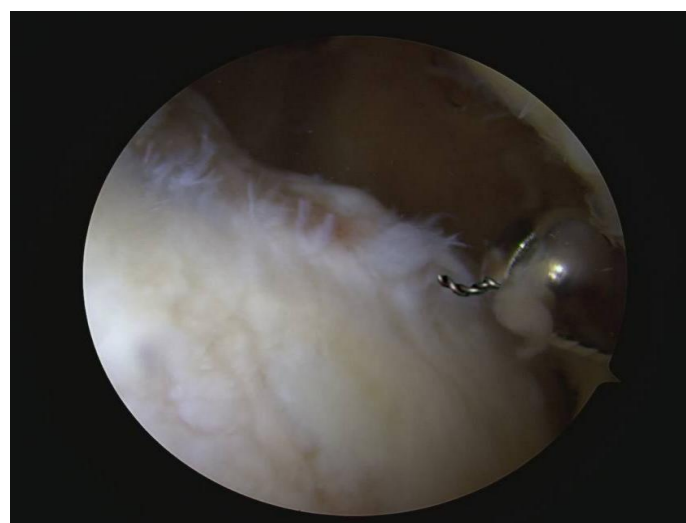
**Figure 4. Intra-operative implant evacuation using arthroscopy**

A diagnosis of symptomatic implant failure with intra-articular migration was made, and the patient underwent arthroscopic removal of the implant. Intraoperative observations indicated a displaced K-wire extending into the joint cavity. The wire was effectively removed utilizing arthroscopy instruments. No chondral injury or intra-articular loose bodies were detected during the surgery. Postoperatively, the patient received intravenous antibiotics and analgesics and was meticulously examined for indications of infection and wound-related problems. Early mobilization and organized physiotherapy were commenced to promote the restoration of knee joint function. The patient had positive surgical recovery, showing gradual enhancement in mobility and absence of early problems.

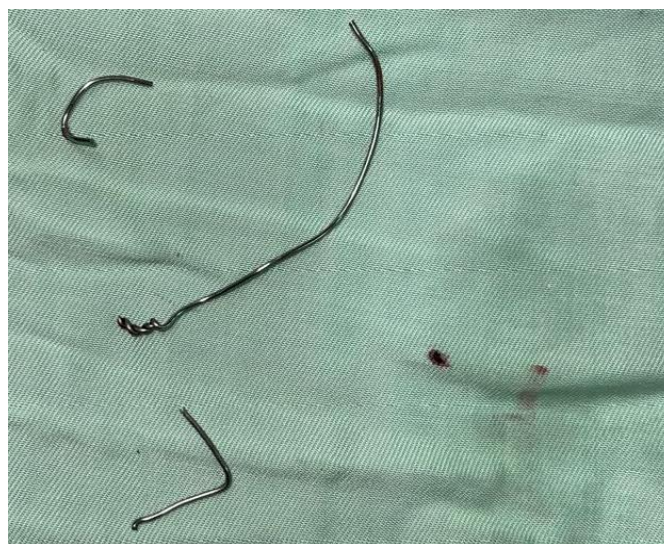
Figure 6. Implant manifestation after evacuation
